Case studies on construction defects on different types of walling system for building

Low Cheau Ming and Md Azree Othuman Mydin

School of Housing, Building and Planning, Universiti Sains Malaysia, 11800, Penang, Malaysia.

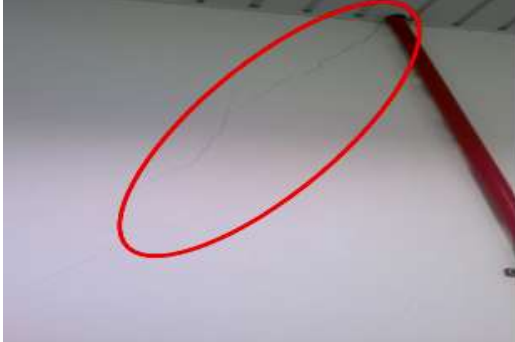
In Hamzah Sendut 3 Library, there is a problem of crack at external wall as shown in Figure 1. The crack was within 1 meter long. It was a crack from the top of the pipe. The condition of the crack is small and does not affect the structure of the wall and the building. Therefore, it is a minor defect.

Figure 1: Diagonal cracks on external wall at Hamzah Sendut 3 Library

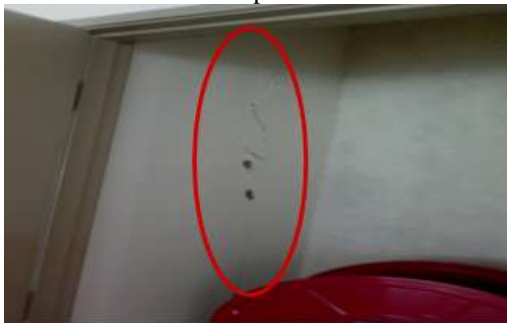
As for Hamzah Sendut 3 Library, there is a store which houses the hose reel system as shown in Figure 2. It shows a vertical crack from the top to the bottom of the wall. The crack was serious at the middle part and the plaster is falling off. This means the condition of the wall is bad and it must be repaired and plastered back with cement plaster.

Figure 2: Vertical cracks from the top to the bottom of the wall at Hamzah Sendut 3 Library

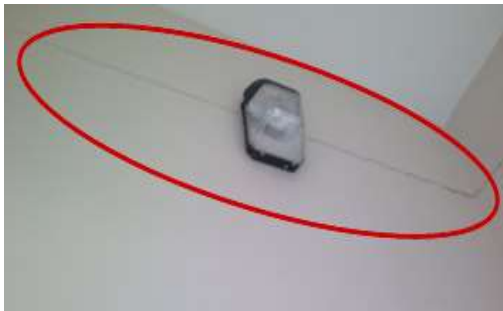
Another problem was a horizontal crack that can be seen on the sides of the light as shown in Figure 3. The defect was located at the exterior wall beside the corridor on the second floor. The crack was probably horizontal and straight across the wall.

Figure 3: Horizontal cracks at wall on the sides of the light at Hamzah Sendut 3 Library

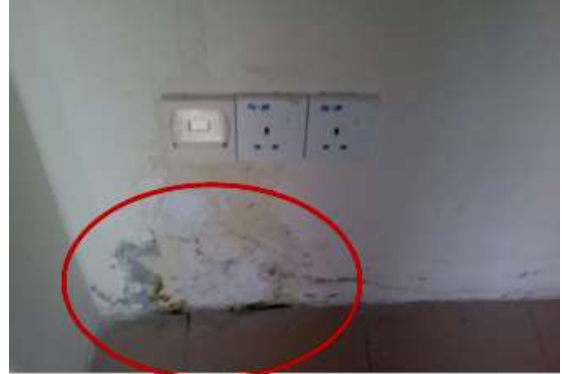
Next, paint peeling on the surface can also be found in the building (Figure 4). This defect was located at the exterior wall on the first floor. It is located beside the electric plug. The obvious sign of the defect can be seen through the different colour of the paint. The original colour of the paint was white and now light pink is visible on the wall. There is also paint overlapping on the defect. The area of this defect is small if compared to other buildings.

Figure 4: Paint peeling on wall surface at Hamzah Sendut 3 Library

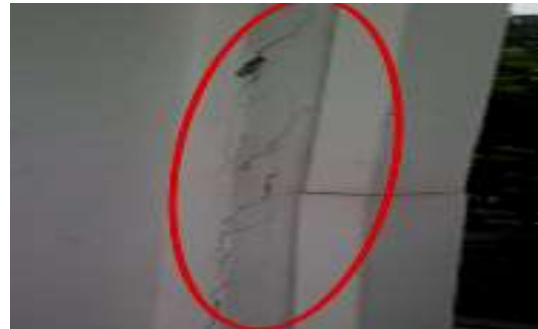
There was a vertical crack on the wall surface as shown in Figure 5. It is at the exterior wall beside the downpipe of K07 building. The defect is not very serious. Other than that, there are many tiny cracks beside the vertical crack. The width of the crack is about 0.3 cm. This shows that the defect will not affect to a building. The crack occurs due to thermal expansion and poor workmanship. Inferior material can also cause the occurrence of crack.

Figure 5: Vertical cracks on the wall surface at Aman Damai Hostel

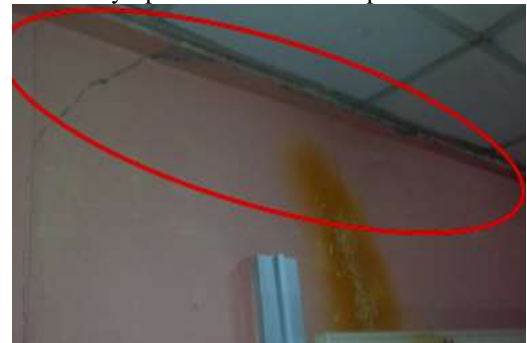
Besides that, another crack appears at the top corner of the wall as been illustrated in Figure 6. It was located in the toilet on second floor. The crack was a long horizontal crack. There was a brown colour mark on the wall surface. This surface of the wall is defined as the symptom of discoloured paint.

Figure 6: Horizontal cracks at the top corner of the wall at Aman Damai Hostel

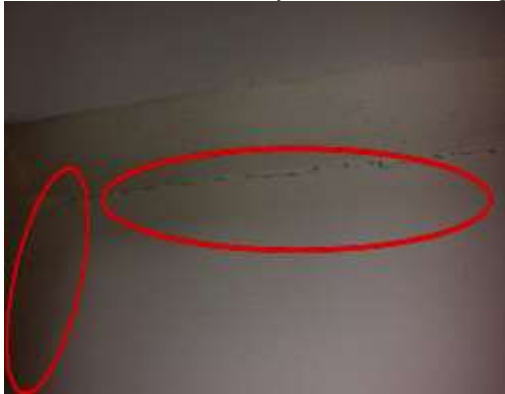
Figure 7 shows horizontal and vertical cracks. It was located at internal wall on the first floor. The cracks occur straight along the wall between joining beam and wall and between column and wall. A crack of the wall was visible outside of the room. This type crack is common at every level of the building.

Figure 7: Horizontal and vertical cracks on internal wall at Aman Damai Hostel

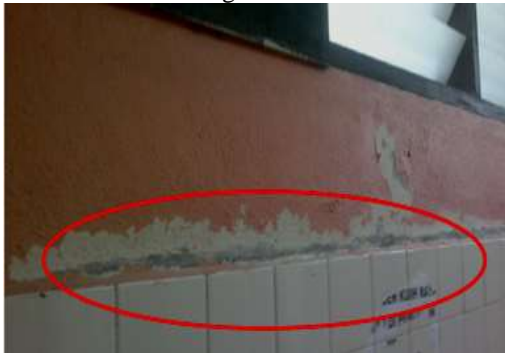
Next, Figure 8 shows the paint in the toilet is peeling. It is on the top of the toilet tiles. This defect was observed at the toilet on the second floor. The original colour of the wall which is pink is being casted. Therefore, we can see the wall surface which is in white colour. This occurred due to the rain water that penetrated into the wall through the window.

Figure 8: Paint peeling occurred on wall surface in the toilet area at Aman Damai Hostel

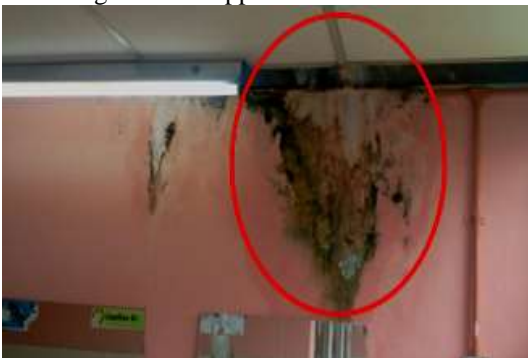
Figure 9 shows a dampness problem at the first floor toilet. The sign of the dampness on the wall shows that there was water leakage from pipe water at the second floor. The wall shows marks of discolouring on wall and a small area of paint peeling. Fungus grows along the water stain. Therefore, there are green marks (colour) on the wall. Other than that, we can see clearly the water flowing from the upper wall.

Figure 9: Dampness on wall area at first floor toilet at Aman Damai Hostel

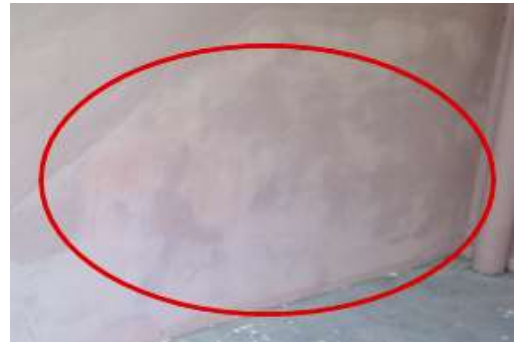
The defect of the wall is discolouring on the surface. The defects are located at exterior wall on the first floor (Figure 10).

The defect is near the staircase. The defect causes the wall become chalking. The pink colour paint is faded. This defect has affected a wide area.

Figure 10: Discolouring on the surface at exterior wall on the first floor at Restu Hostel

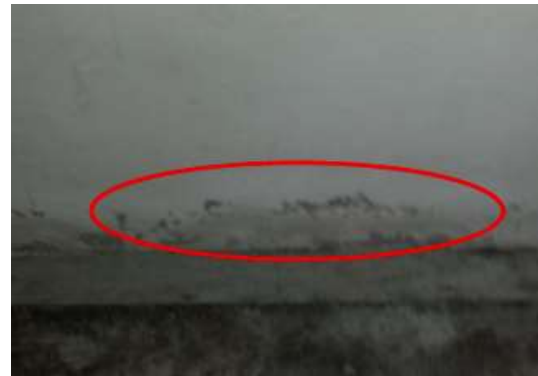
From observation, the walling system at the other floors have similar problem of paint peeling. For example, paint was peeled at the bottom of the wall which is located at the sixth floors. It is located at the corridor as shown in Figure 11. The surface of the wall is discoloured and the original cement plasters are now visible. There is a small drain to drain the water at the bottom of the wall.

Figure 11: Paint peeling at the bottom of the wall at Restu Hostel

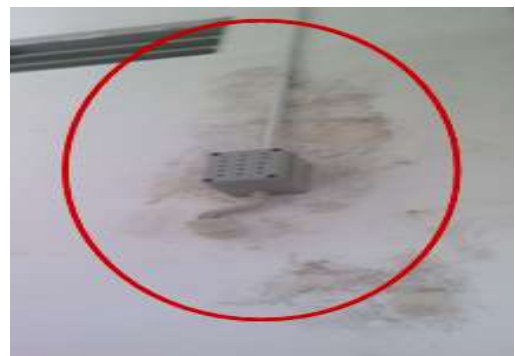
Besides that, almost every floor is having serious dampness problems at the exterior wall of the toilets (Figure 12). The water has leaked through the wall from the toilet. There is a sign that shows the dampness problem on the wall. Water stain is caused by dampness and it covers a wide area. Besides that, paint is peeling because of the wet condition of the wall. White paint on the wall is peeled and the surface of the wall becomes rough.

Figure 12: Serious dampness problems at the exterior wall of the toilet at Restu Hostel

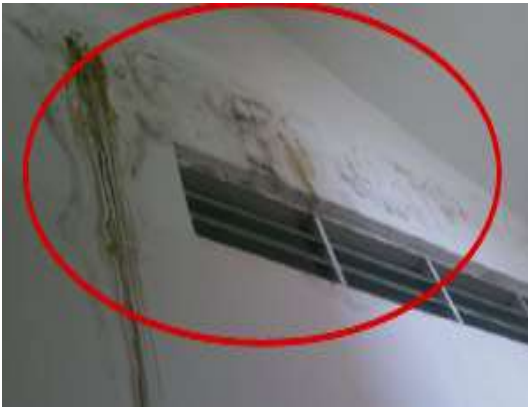
There is another dampness problem on the second floor. It occurred because the water penetrates through the porous of the wall (Figure 13). This wall is located at toilet. The dampness problem affected a wide area at the top of the window. There is

vertical sign of water stain at the left corner of the window. It also shows that fungi grow on the wall. The water stains on the wall also show the brownish stain.

Figure 13: Sign of dampness on wall surface at Restu Hostel
