Chemical-Technological Characterization of Some Georgian Medieval Arch Bridge Mortars

The chemical and mineralogical-petrographic composition of mortar of several arch bridges (Makhuntseti, Varjanauli, Machakhela, Dandalo and Tsoniarisi) in Adjara region (Georgia) has been studied. Chemical, petrographic and X-ray diffractographic analysis methods were used for the research.

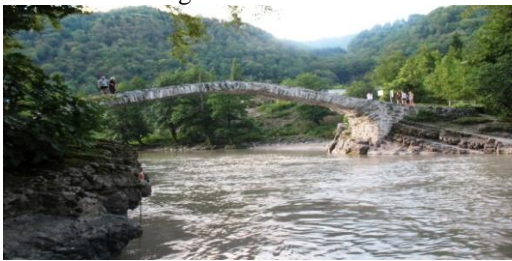
Figure 1. The stone bridge in Makhuntseti.

The bridge is quite big and rests on the original mountain abutments. The bridge is constructed of torn stones on the lime mortar. On both sides of the bridge the torn stones of acingarch is used. Among these rocks there are uneven stones and mortar solution. The facing stones are vertically arranged on both sides of the bridge over the entire length [5,6].

The Makhuntseti bridge is located in the village of Makhuntseti in Keda region.

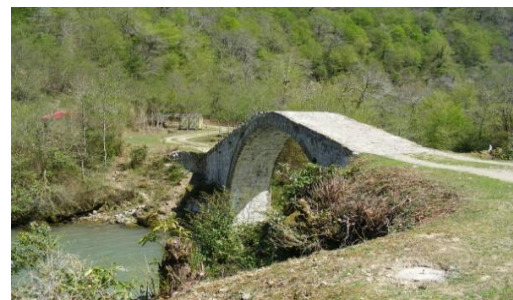
Figure 2. The stone bridge in Varjanauli.

The bridge is quite large, wide and high with a semicircular shape. It is built with chisel square stone and fence stones on the mortar. The torn stones of ledge facing arch are used for the construction. The lime solution is between the stones. The facing stones are vertically arranged on both sides of the bridge over the entire length. The same arrangement follows the bridge arch near the abutments [5,6].

The Varjanauli bridge is located in the Kintrishi river gorge.

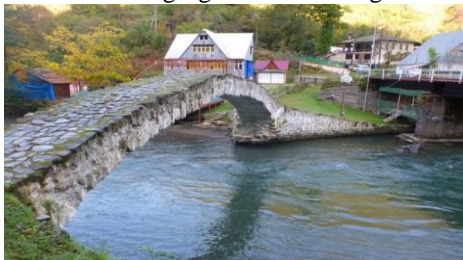
Figure 3. The stone bridge in Machakhela.

Quite a narrow, semi-circular arch bridge is constructed using fence stones and tornstones on lime mortar. On both sides of the bridge two rows of the tornstones of acingarchis used. Among these rocks there are uneven stones and lime solution. The facing stones are vertically arranged on both sides of the bridge over the entire length [5,6].

The Machakhela bridge is located in Khelvachauri region in the Machakhela river gorge near the village Machakhela.

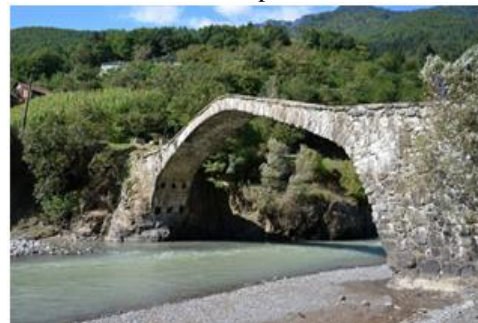
Figure 4. The stone bridge in Dandalo.

Bridge is located in the village Dandalo in Keda region, in Adjaristkali river gorge, in the narrowest part of the river.

A wide bridge is constructed on limestone mortar. The facing arch torn stone is used for the construction among which are uneven stones and lime sulfide. The facing stones are vertically arranged on each side of the bridge over the entire length [5,6].

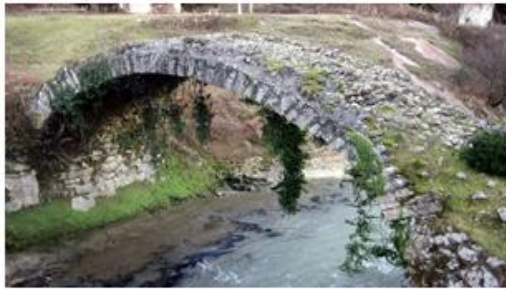
**Figure 5. The stone bridge in Tsoniarisi.**

The Tsoniarisi bridge is located in the village Tsoniarisi in Keda region where the Tsoniarisi joins the Acharistskali river. The bridge collapsed in April, 2007; Only the abutments of the bridge are retained [5,6].
