An evaluation of the physical planning flood control measures adopted in kubwa town, federal capital territory, Abuja

Musa Dalil¹ and Usman, Mohammad Yamman²

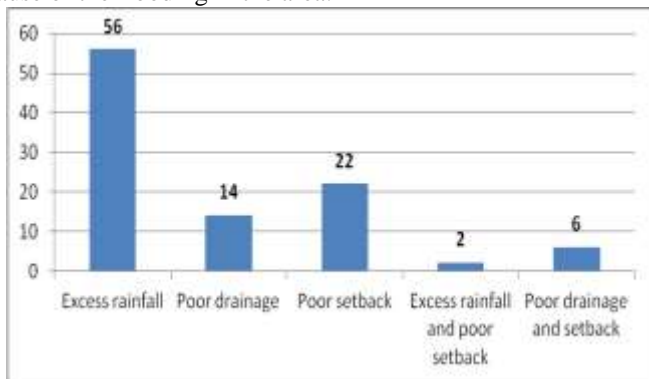
Fig 1.5: Factors of flooding (%)

The opinions of the residents of the sampled neighbourhoods were sought as regards the immediate and remote causes of the perennial flooding ravaging the community. This was done in order to feel their pulse concerning some of the negative environmental activities they engage in. The result showed that 56% of the residents of Kubwa believe that excess rainfall is the cause of the flooding in the community, 14% of the respondent said it was poor drainage network, 22% of them stated that poor setback was the main cause of the flooding in the area.

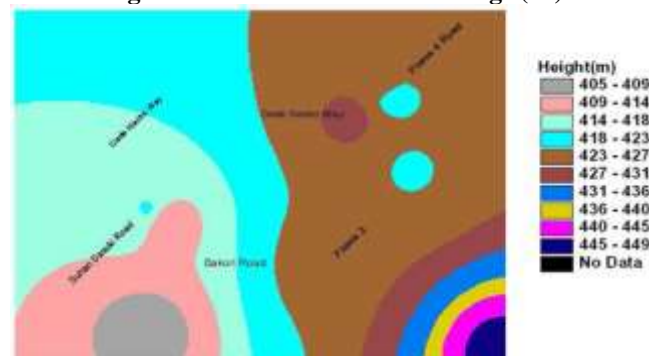
Fig 1.7: Topographic Map of Kubwa

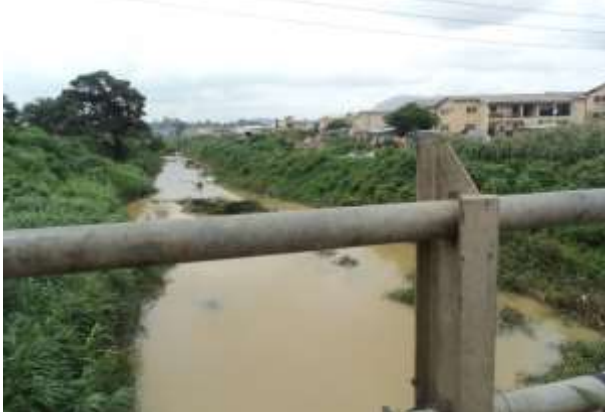
Plate IV: an obstructed canal causing the ponding of excess rain water

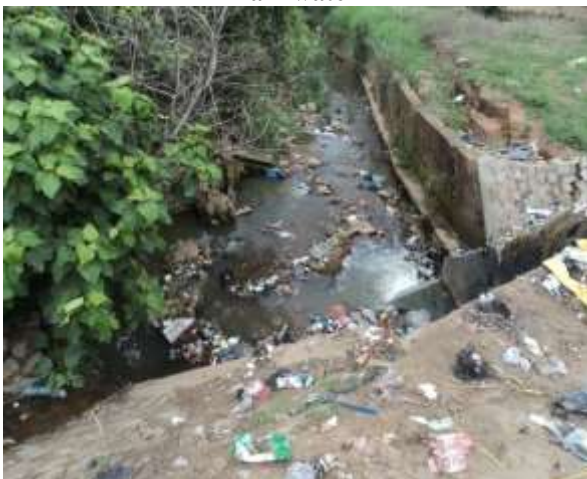
Plate V: an open drainage used as a refuse dump

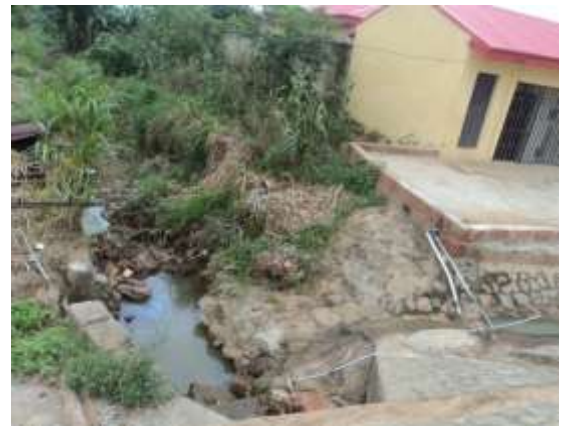
Plate VI: an housing unit constructed just at the edge of a natural water way
