Elixir Historic Preserv. 75 (2014) 28001-28005

Factor affecting roof leaking focusing on clay roof tile and asbestos roof for Malaysia heritage buildings

Roslan-Talib^{1,*}, AGhafar-Ahmad¹, MohdZailan-Sulieman¹, David Boyd² and Susan Hayhow²

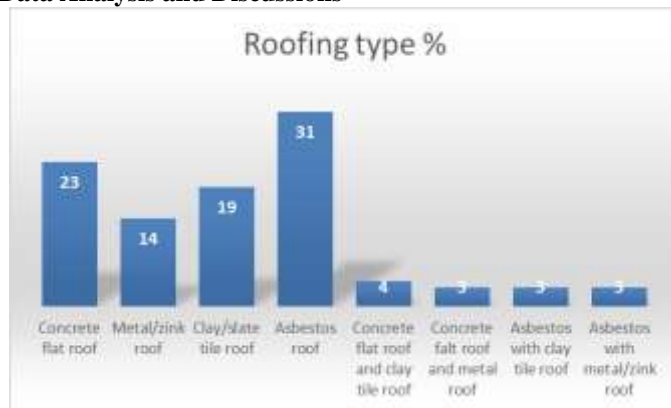
Figure 1. Classification of roofing types for the buildings selected for this research

After having done the analysis from data collection, it seems like the asbestos roof (see Fig.1) is the most material being used as the roof covering structure for this study. This is due to from the number of Melaka traditional houses that has been in the list considered a good added value to Melaka State Government tourism pack. Most of these house having the 'nusantara' tropical architectural design with the sharp high pitch roof type to minimise the running rain water during the rainy monsoon season end of the year (particularly on the Malaysia's peninsular side). As the process of removing these asbestos roof become more regular in recent years, there are still some houses where the individual owners require certain financial assistant especial from the local government to replace those defective asbestos roof to the new asbestos free roofing type which much more available on market with various types even with green product label and having similar asbestos corrugated profile. The next roofing type from the list is the flat concrete roof which is derived from a simple abstract geometrical modern shape thus require proper waterproofing system to cover its top as tight as possible from water seepage. With the waterproofing technology in the advance stage right now, proper installation on the system with superb supervision for the concrete flat roof; the modern boxy design for the flat roof can be done and as in favour for the designer architect to satisfy. The analysis indicated that after concrete flat roofing, the clay or slate roof tile is the most in numbers as well as the metal or zinc type of roof. On the bottom of the list are the buildings where a combination of different type of roof from the flat roof combining with metal, clay or asbestos roof also among the old buildings type in the data finding research.

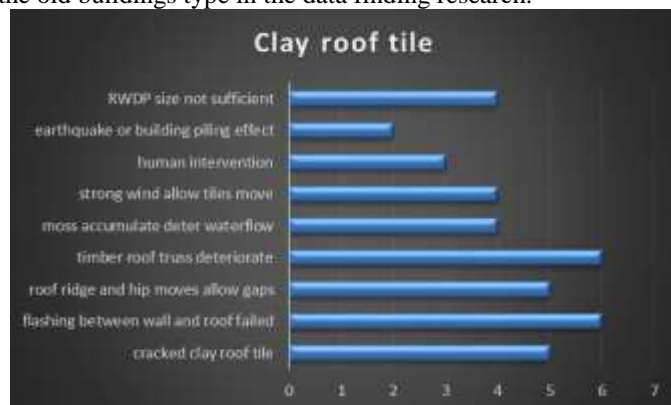
Figure 2. Identified factors leading to water seepage on clay roof tile for the case studies

The above chart (Fig.2) showing 9 identified typical defects always happened to the clay roof tile or slate roof tile as well on selected old structures or historical buildings in Malaysia.

From the research list finding, clay roof tile is the third most frequent roofing type found after surprisingly asbestos roof and concrete flat roof. The analysis indicated that the most problematic scenario on the leakage for the clay roofing is the deterioration of the timber trusses that permit the rain water seep through the moved roof tiles hence giving problem to the building interior. The timber trusses normally deteriorated due to the presence of the termite that attacking the wood. Most of the timber trusses constructed during that time may not have been treated rightly with the anti-termite chemical or through the time period the chemical may not worked and normally timber work require highly careful maintenance with the owner traditional treated it with the special wood oil. Nowadays, most of the building owner especially the house owner prefer to have metal roof trusses as the main element of their roof covering structure to eliminate termite problem hence be able to overcome at least the roof leakage part. It seems like the fail of flashing also contributed important roofing defects for the case studies.

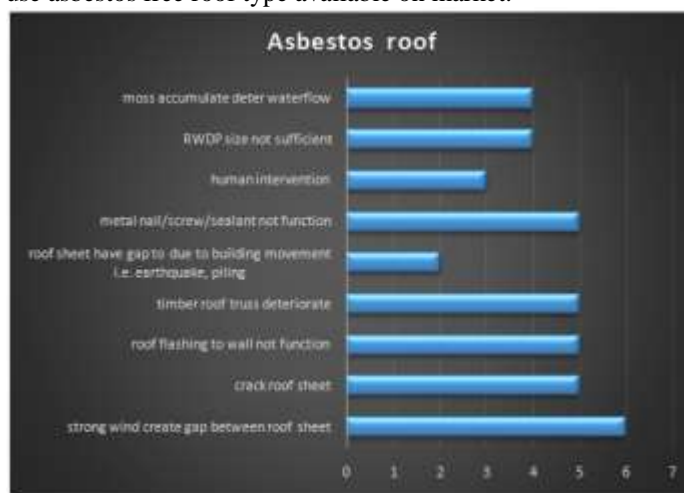
Figure 3. More identified factors leading to water seepage on clay roof tile for the case studies

The chart below (Fig.3) shows 9 typical seepage situations always occurred through the defected asbestos corrugated sheet or asbestos roofing extracted from the data collection done. It seems the most defect cases for most heritage buildings with asbestos roofing has gap in-between the sheets due to the high wind speed effect as well as cracked on the sheet, flashing problem, deteriorate timber trusses and nail or crew not function as well as expired sealant.
