# Analysis of Physicochemical Properties of Lake Beseka; "The Ever Growing Lake of Ethiopia's Great Rift Valley" Fuad Abduro<sup>1,2,\*</sup> and Gelaneh W.Michael<sup>2</sup>

In this work we reported the status of one of Ethiopia's Great Rift Valley Lakes; "The ever expanding Lake known as Beseka" in respect to water quality parameters. A composite sample was prepared by combining equal volumes of water samples taken from five Sampling sites. Five physical parameters (pH, DO, EC, T° and Turbidity) were determined for all samples at the spot of sampling while other physical parameters such as TSS and TDS were determined in the laboratory. AAS was used for the determination of heavy metals Pb, As, Cd, Cr, Fe, and Pb while spectrophotometer was used to determine water hardness, total chlorine, NO3-, PO43-, NH3, SO42 Alkali metals Na and K are determined by Flame Photometer. The findings indicated that the lake was found to be alkaline with pH above nine and brakish with TDS value of 2569.70 mg/L. The measured higher values of EC and turbidity resulted from higher values of TDS and TSS. Also these values are much higher than the acceptable values for surface water such as lakes. Simi

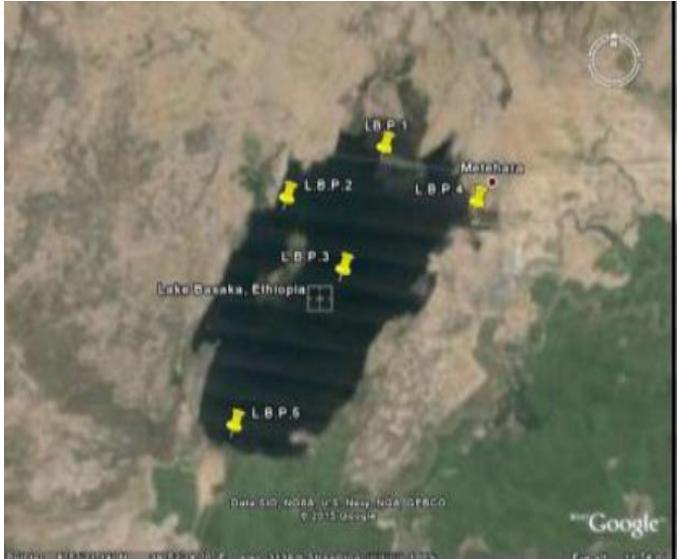
Figure 2.1. Boundaries of Lake Beseka in 2015 and its watershed and sampling sites (Source: Google Earth open source).

Lake Beseka (latitude  $39^{\circ}51$ '-  $31^{\circ}53$ 'N and longitude  $8^{\circ}52$ '-  $8^{\circ}54$ 'E) is located in the northern half of the Ethiopian Rift Valley close to Metehara Town at the junction of the Main Ethiopian Rift (MER) and the Afar Triangle about 190 km to East of Addis Ababa. Fringed either side of the main highway and railway line, the lake has been threatening Ethiopia's only access to the Port of Djibouti. It covers an area of more than 40 km<sup>2</sup> with a mean depth of 6 m and maximum depth of 11 m. Moreover, the surface area of the lake has been increasing continuously and its size has changed from 3 km2 in 1964 to more than 42 km<sup>2</sup>(Tenalem, 2005).
